Test Report No.: IT14/1691-00
Applicant: MARTIN S.r.l.
IT – 25050 PROVAGLIO D'ISEO (BS)
Type: 70170/HYG

TEST REPORT

No: IT14/1691-00

| 1.0. | <u>Equipment under test:</u> | Stainless steel closing system |

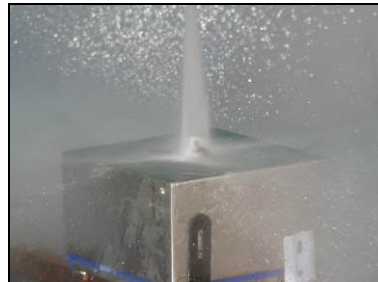
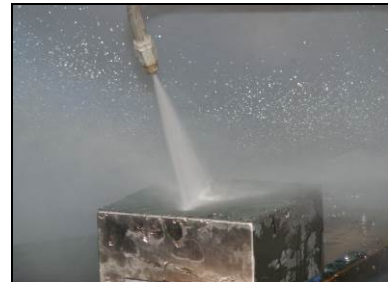
Photo test set-up:

The test sample, after the dust test, was fixed as agreed with the applicant on the turntable and subjected to the high pressure/steam jet cleaning, with the following parameters:

Water temperature: (80 ± 5)°C
Water flow rate: (15 ± 1) l/min
Water pressure: (90 ± 10) bar
Fan jet distance: (125 ± 25) mm
Fan jet position: 0°, 30°, 60°, 90°
Sample speed rotation: (5 ± 1) rpm
Duration: 30 s (for each jet position)

Used equipment: IPX9K test system (ITAP08041)

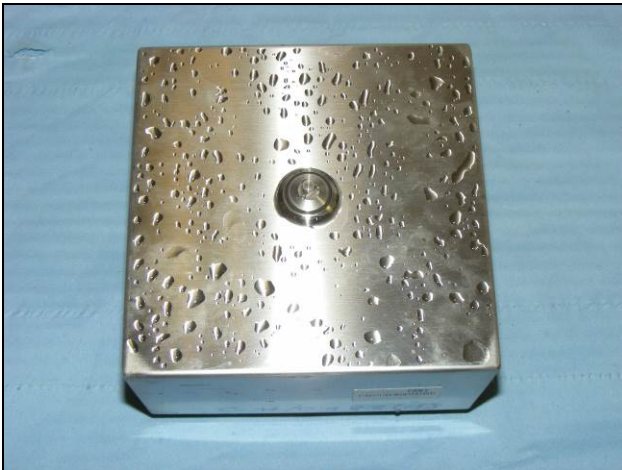
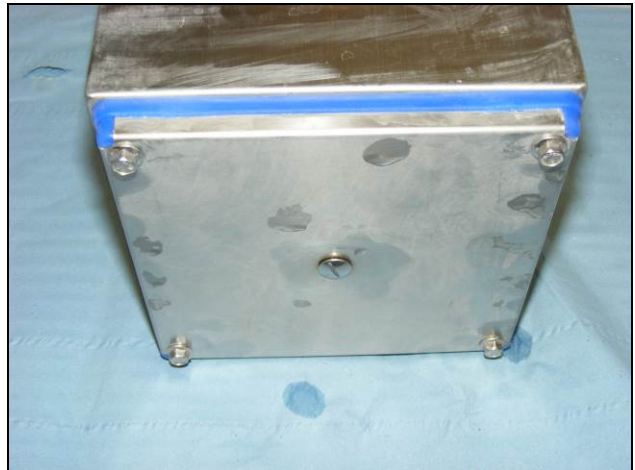
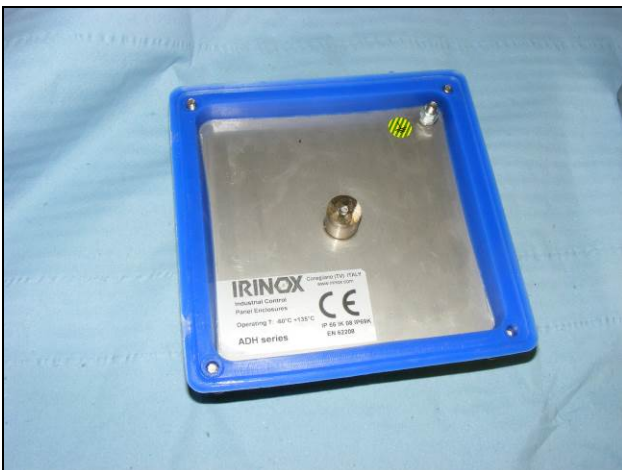
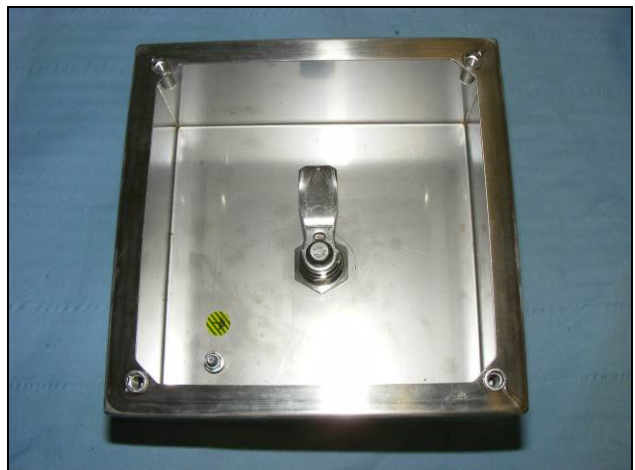
Photos of sample C-14/0483 (1) after the IPX9K test

Result: After the opening of the box, no visible presence of water.
No visible damage was detected after the test.

- (*) The internal check was carried out after the IPX9K test (see test protocol IT14/1691-00/02 and attached photos).
